# Reserve Study Update

## The Villages of Westminster Williamsburg, VA

October 2015

**TAM Project No. 13084-15**

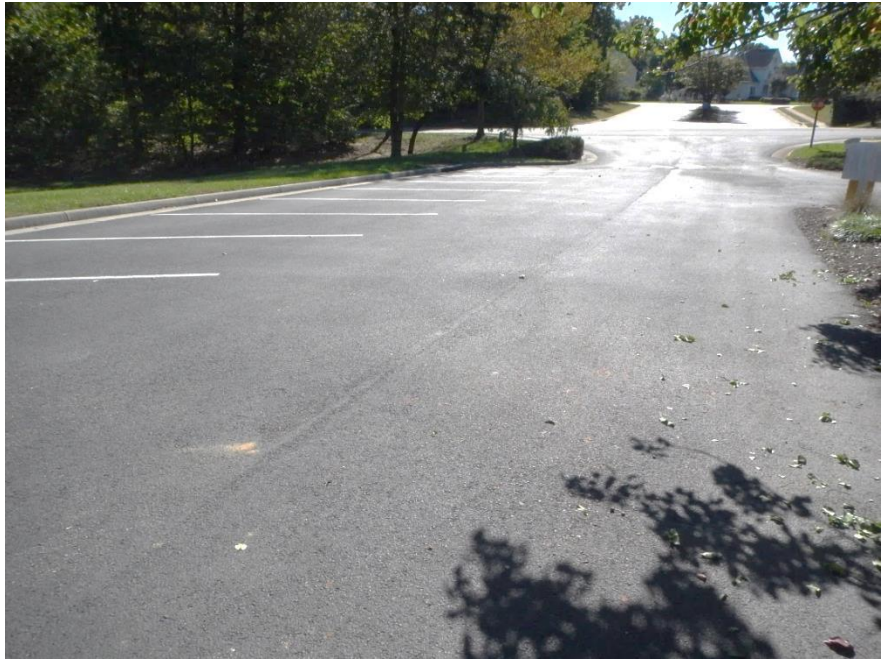
## **Components 1 & 2 - Asphalt Parking Lot, Surface Sealing and Marking**

This includes the asphalt parking lot at the clubhouse. It is in serviceable condition at this time. The parking lot includes parking for a total of 28 vehicles which includes two reserved parking spaces for handicapped vehicles.

Parking lot striping and seal coating appears to be in generally good condition. We recommend that these

be sealed and that the entire surface be seal-coated with an asphalt sealer to protect it against harmful petroleum products from parked cars and to prolong its service life every five years or so.

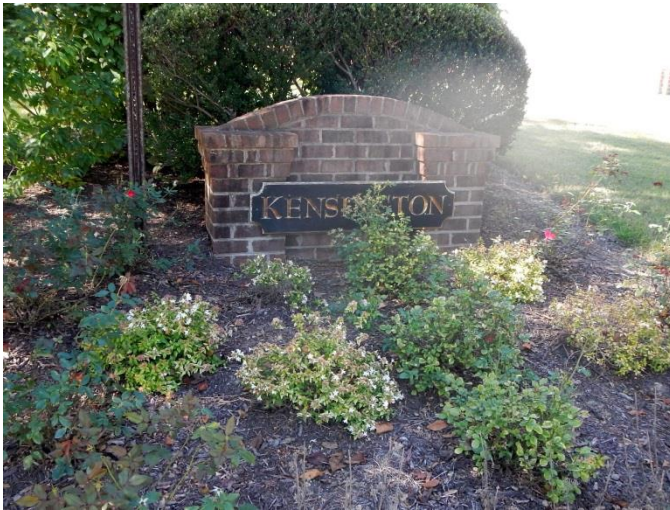
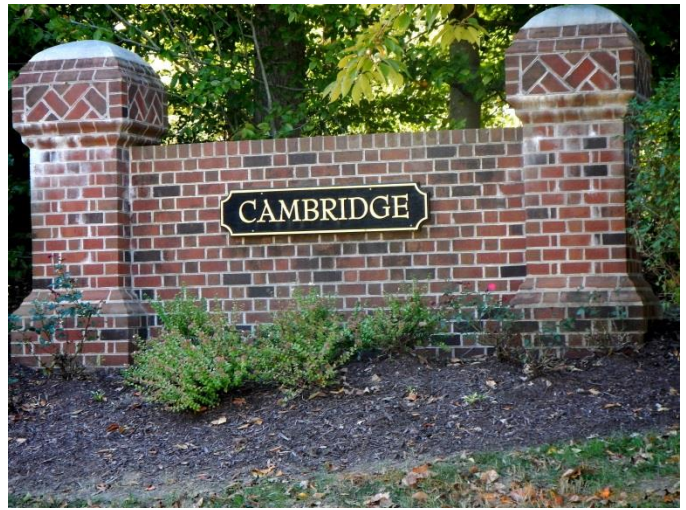
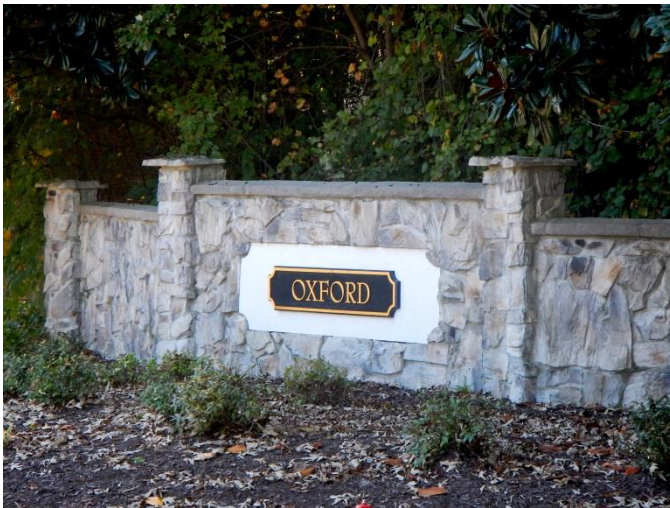
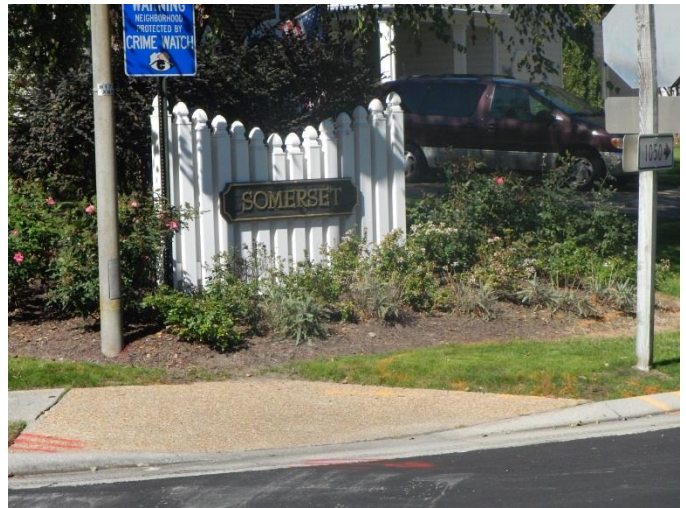
### Component 3 - Neighborhood Entrance Signs

This component is for all of the neighborhood entrance signs, and does not include the monuments (see Entrance Masonry Restoration). These signs are made in the same way as the main entrance sign, and have the same projected service life, although they are older. Presently, these signs are all in serviceable condition although the sign for Somerset is being replaced with the masonry one.

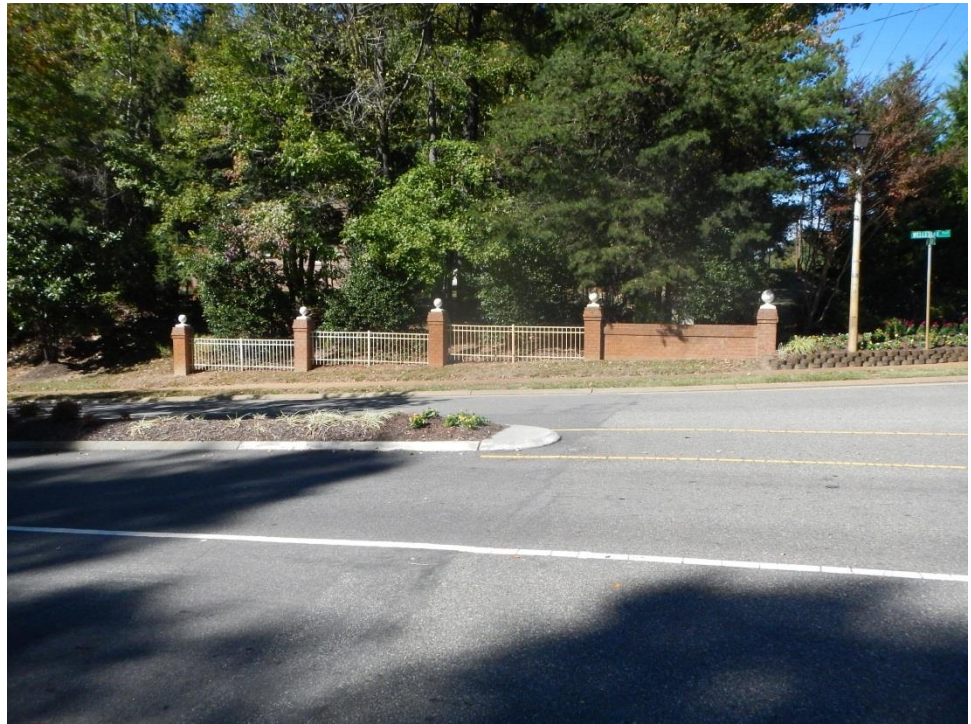
## Component 4 - Entrance Masonry Restoration

This component consists of the brick entrance monument sign, colonial styled piers and walls at the front entrance and colonial styled walls at each side of the road at the first intersection, the brick masonry walls at the Kensington and Cambridge signs, and the stone masonry wall at the Oxford sign.

The total surface area of all the walls is approximately 2,100 s.f. Walls appear to be in serviceable condition, and they should have a very long service life. Masonry restoration and repointing will be required from time to time.

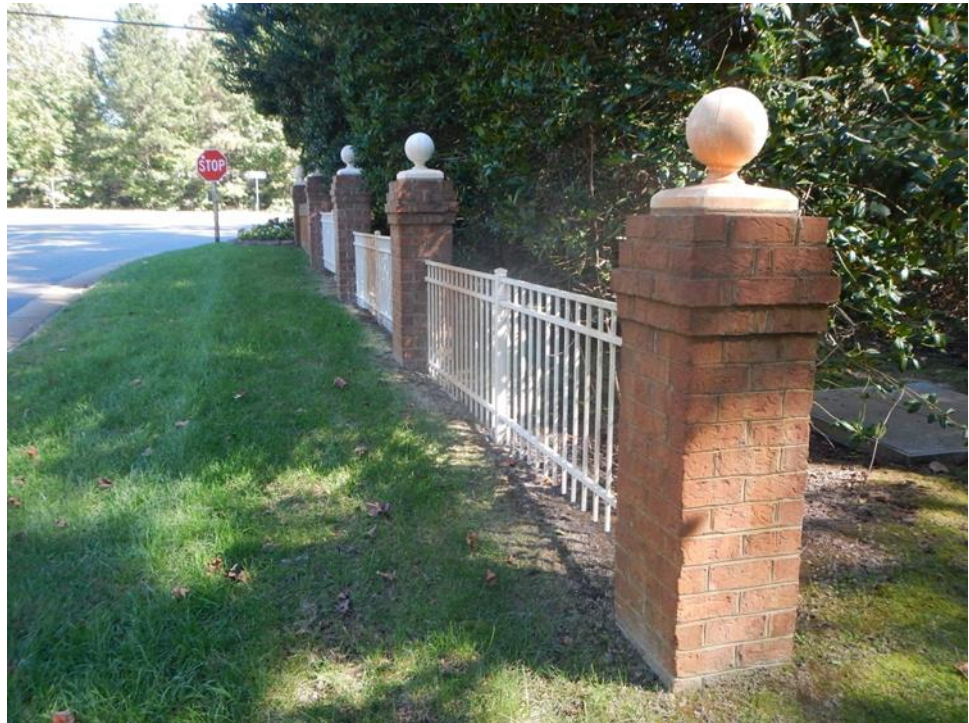
## Component 5 - Main Entrance Metal Fencing

There are six double spans of white aluminum picket fencing running between the brick walls and piers at the front entrance. Some oxidation of the painted surface is occurring at this time. These fences can be periodically painted to be maintained. The main type of deterioration that may affect these is

long term differential settlement of the piers and corrosion of the aluminum that weakens fasteners between members and between the fence sections and the piers.

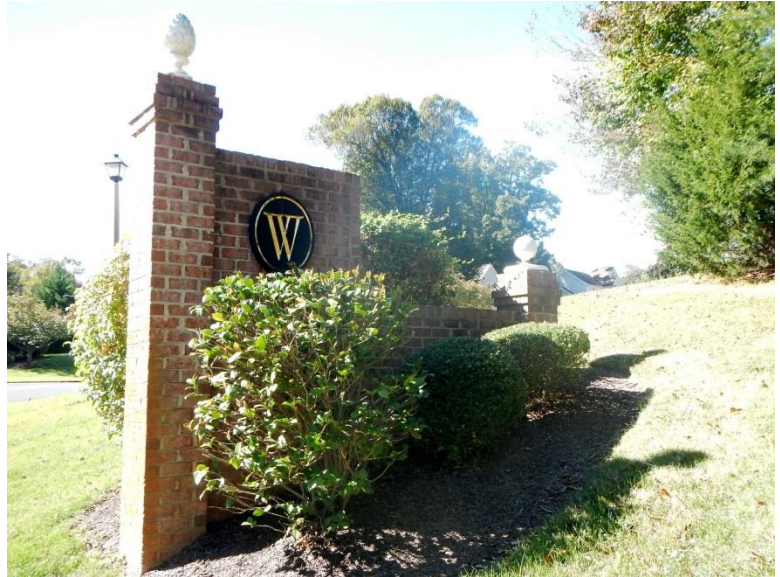
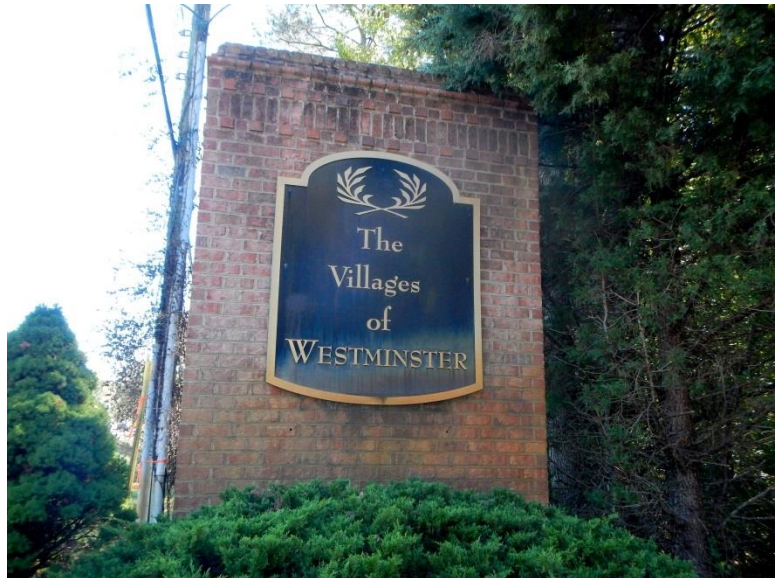
## Component 6 - Main Entrance Signs

In 2008, the existing Villages of Westminster entrance sign was replaced with a new placard sign made of high density urethane (HDU), painted, with gold leaf lettering. In the same year, a second sign was added on the back-side of the monument (facing east on Rt. 60). This type of sign is impervious to rot and decay, but is still susceptible to weathering and physical damage.

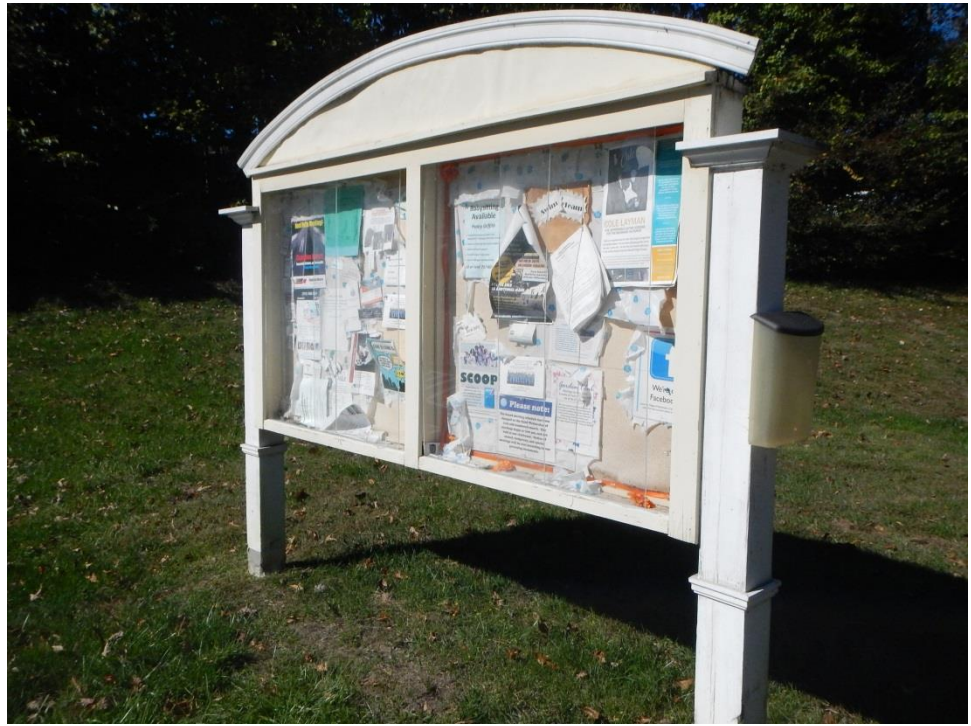
## Component 7 - Community Bulletin Board

The current community board is in poor condition and being replaced with a new wall-mounted bulletin board which will be mounted on the exterior wall at the clubhouse entrance.

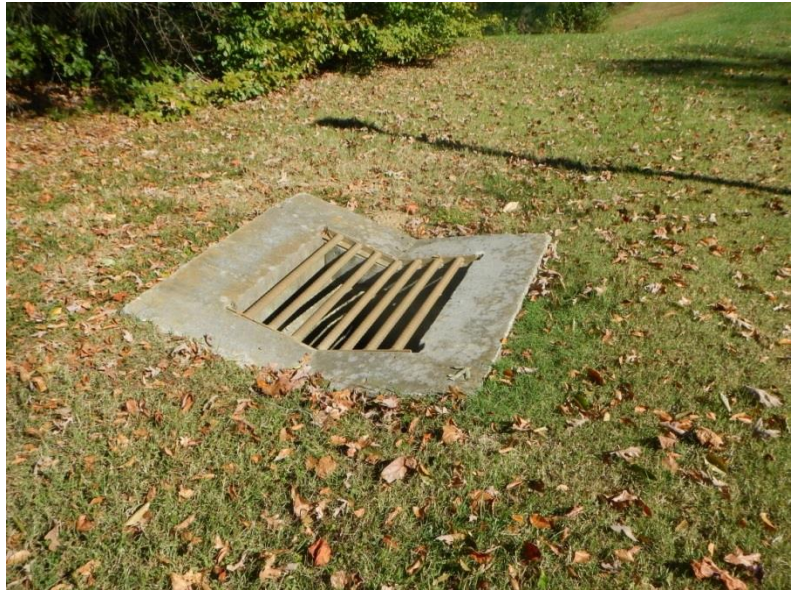
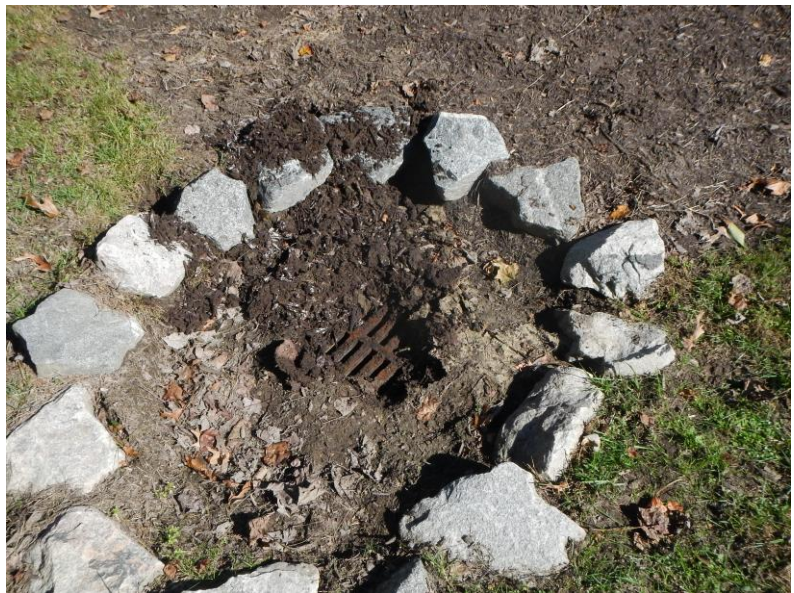
## Component 8 - Yard Drains

In 2008, two yard drains were constructed to replace two inadequate original drains.

We observed five yard drains throughout the community including two at the back of the development between Glen Wilton Lane and Sommerset Lane between the row of houses along the rear of the development. We also found a large yard drain adjacent to the main drive at the clubhouse pond and an additional yard drain adjacent to the pool deck at the front of the clubhouse, left side.

Regarding the surface yard drain located at the clubhouse directly at the front left corner of the pool deck. We found it to be completely clogged with several inches of mulch and dirt. Steps need to be taken to ensure that this drain is kept clear at all times and may require reworking the area around the drain to prevent it from getting clogged.

There is a fifth yard drain located on Chelsea Crescent lane which drains the wooded area behind the houses along Glenn Wilton Lane.

These drains should be reevaluated from time to time and efforts must be made to make sure that they are kept clear at all times.

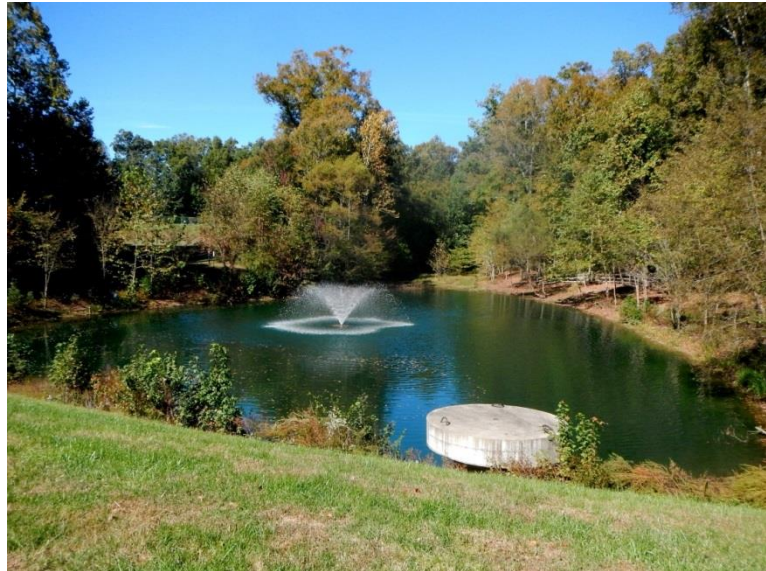
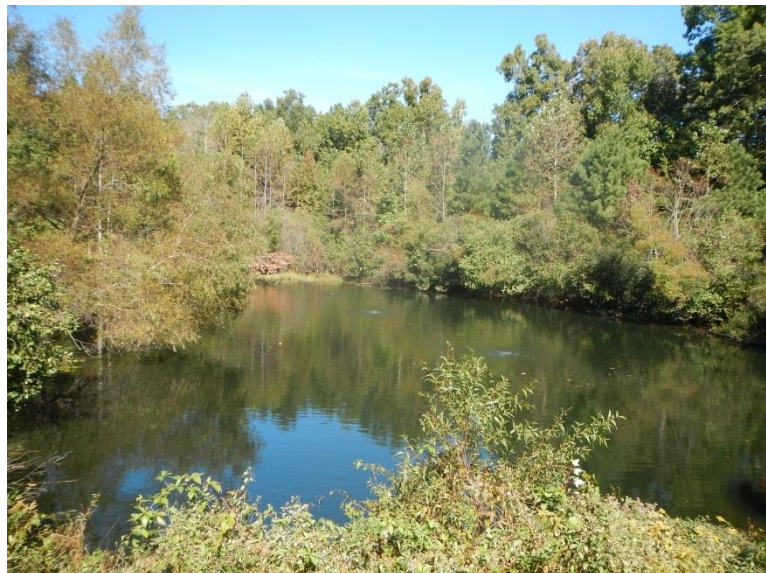
## Components 9 & 10 - Pond Dredging

Westminster has two wet ponds - the Club area pond and the Oxford neighborhood pond. These ponds are small - medium sized BMP's and are basically excavated areas in the ground. They each have, at their downhill sides, an earthen berm that can be considered as a

"dam". These berms, however are broad, low land masses with a significantly large proportion of soil to the area of water potentially contained. We do not foresee the necessity to replace these dams in the future.

At the Clubhouse pond we observed a small slump area at the front of the pond adjacent to the road on the dam and a significant amount of sediment buildup at the rear of the pond where drainage sources drain into the pond at the rear. This should be reevaluated now to determine if work should be accelerated.

We also observed evidence of recent beaver activity around the Oxford pond.

A BMP pond is required to be maintained be free from vegetation overgrowth and will require dredging from time to time as sediment begins to fill the pond in.

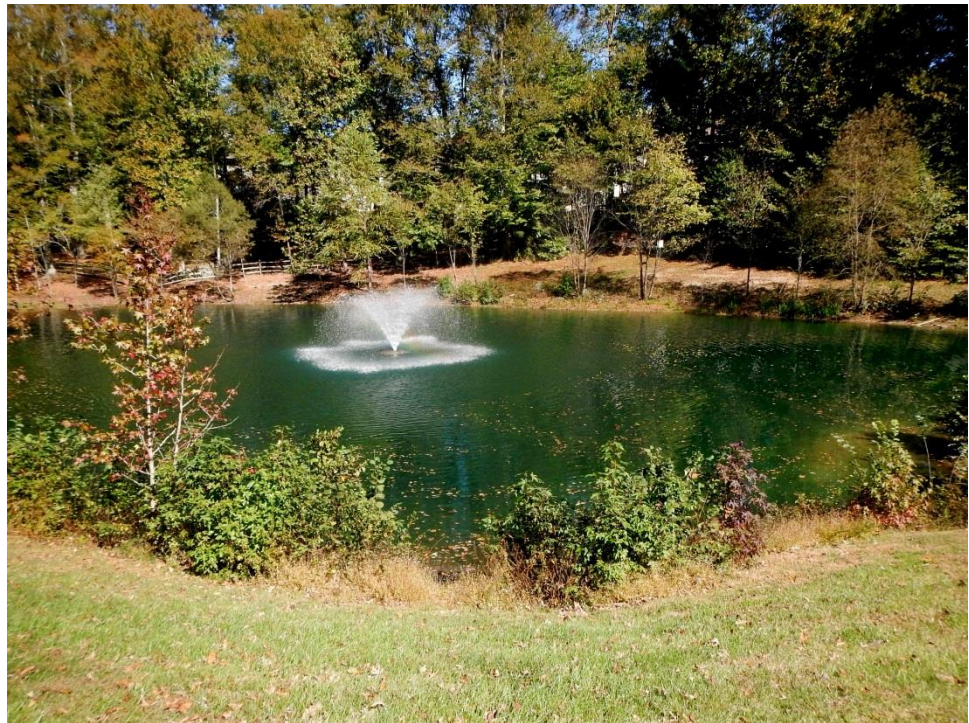
### **Component 11 - Pond Aerators**

The aerators include two types including a fountain type aerator at the Clubhouse pond and a bubbler type aerator at the Oxford pond. The Oxford pond aerator was installed in 2014.

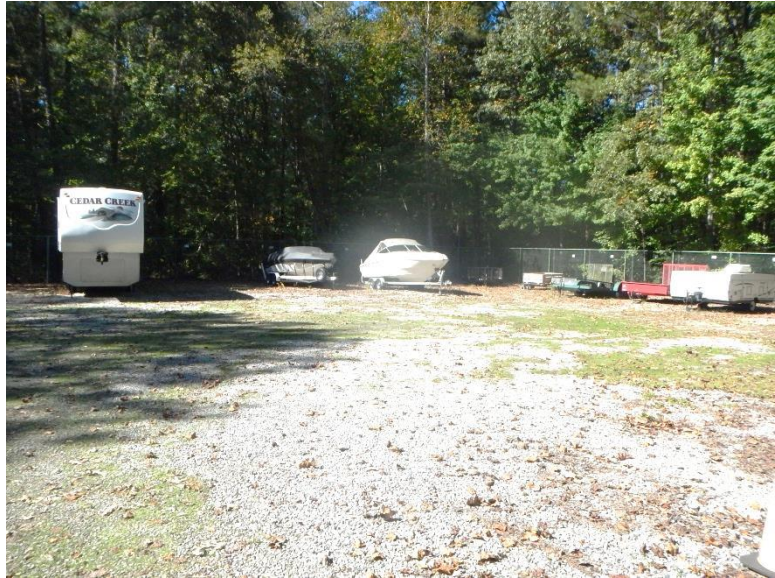
## Component 12 - Recreational Vehicle Lot and Road

The recreational vehicle lot and the road leading to it are both comprised of crushed gravel. Over time the gravel and driving surfaces become rotted and require additional gravel and regrading.

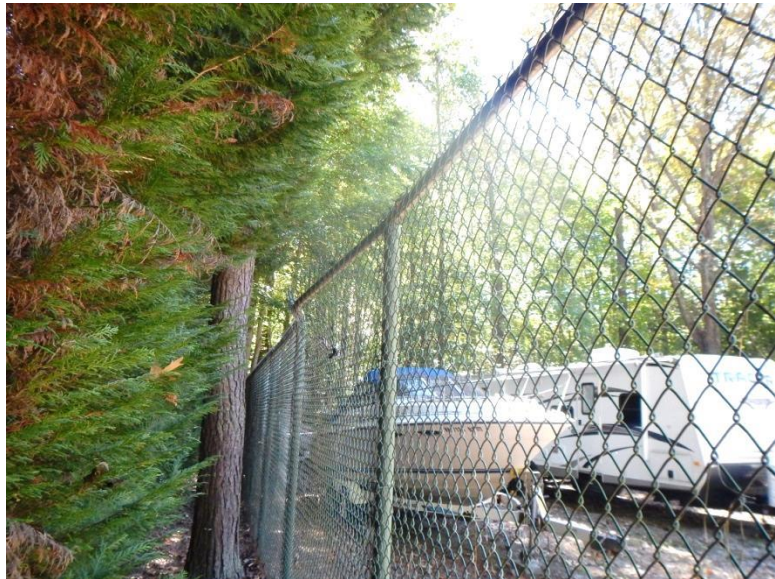
## Component 13 - Chain Link Fence

The chain link fence at the recreational vehicle lot consists of painted 9 gauge fence fabric (chain link) on galvanized 2 1/2" posts and 1-5/8" rails. Over time the paint will break down. Later, the galvanizing wears off - primarily on the fence fabric, allowing rusting to begin. The combination of impact damage and declining appearance quality from rust will cause replacement of the fabric.

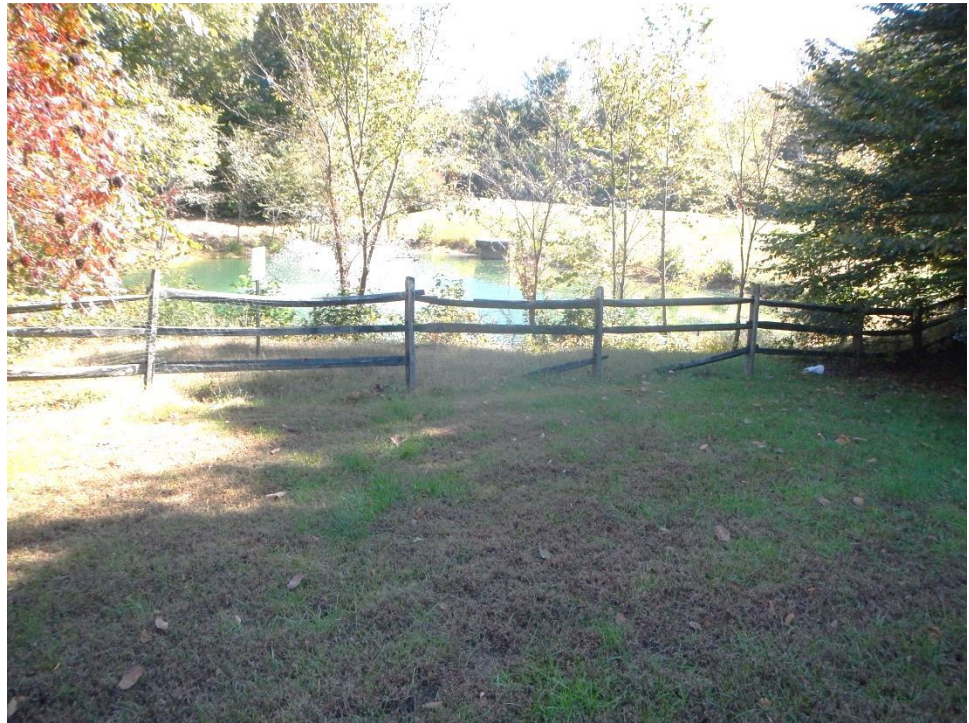
## **Component 14 - Wood Split Rail Fence**

The fence along the pond side of the soccer field and on around the pond (at the clubhouse) is a 3-rail wood split-rail fence with welded wire mesh fabric strung over it. This type of fence can easily be replaced in individual parts as required, however overall weathering will ultimately necessitate replacement of the entire fence.

The wood split rail fencing around the club area pond is in fair to poor and failed condition. Much of the split rail fencing along the rear perimeter where the pond is fed by several inlets is missing, damaged, or fallen over. It appears as though the split rail fence was intended originally to circle the entire perimeter of the sides and rear portion of the pond and the inlets to prevent entry.

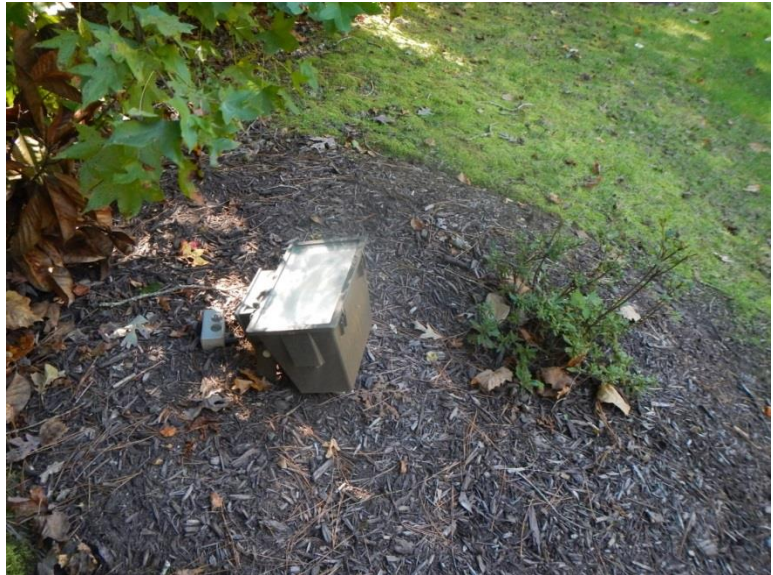
### **Component 16 - Entrance Lighting**

We counted seven (7) floodlight fixtures with 120v high intensity discharge fixtures - The estimated replacement cost includes all fixtures and associated underground wiring.

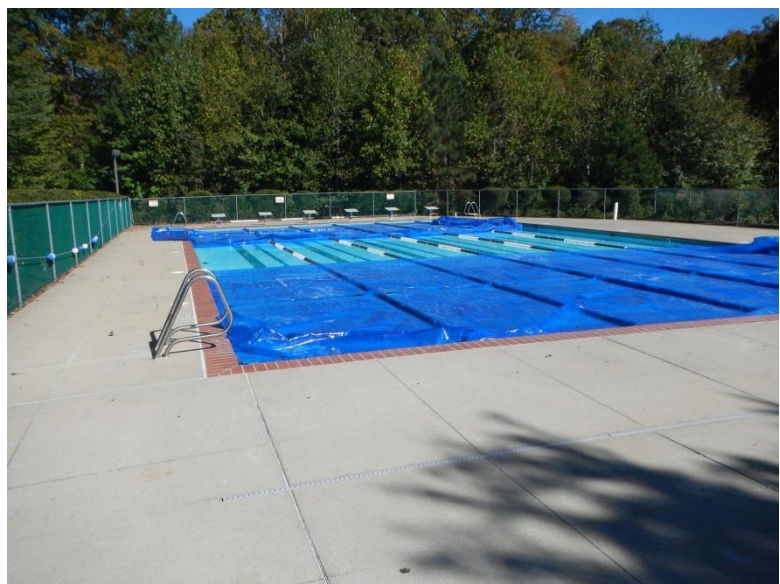
### **Component 18 - Swimming Pool Resurface**

The original Marbelite pool surface was covered with a fiberglass coating in 2005. This surface is less expensive than new Marbelite. It will likely have a similar service life. The pool was partially covered when we visited.

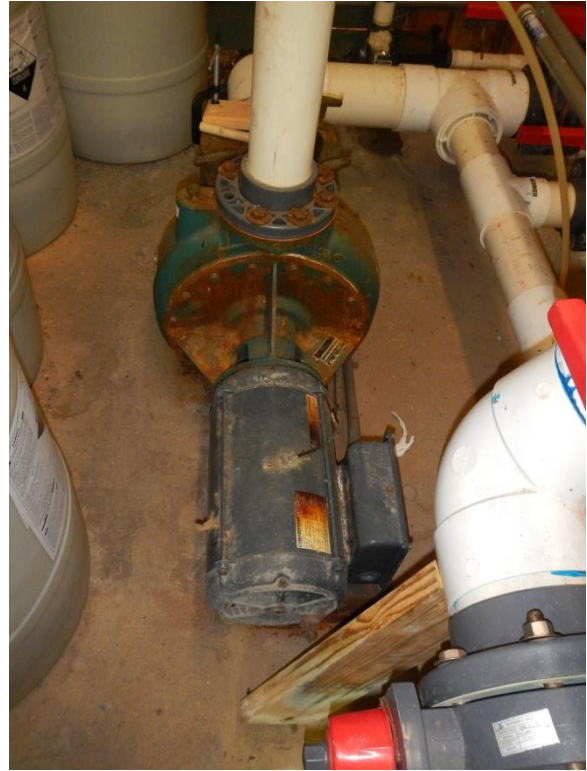
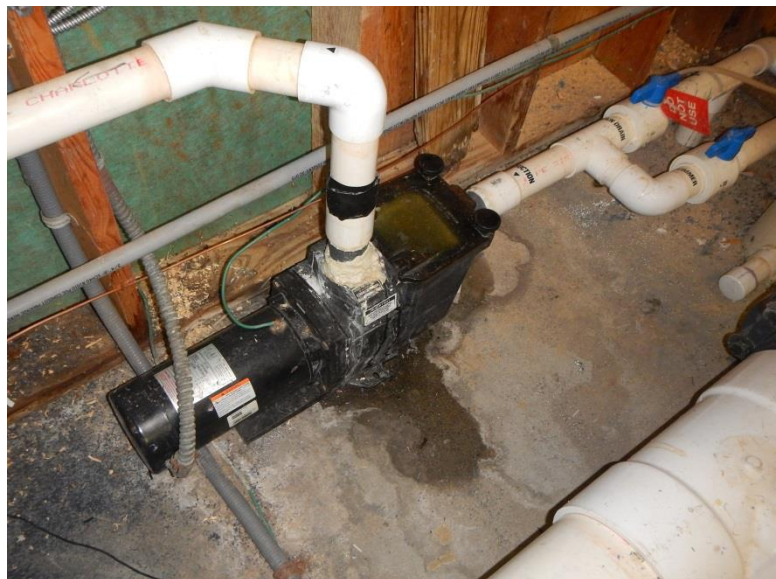
## Component 19 - Pool Equipment – Replace

The components in the pool equipment room include 5 sand filters, 2 pumps, motors and associated bells, piping manifold and electronic chemical controls. Three of the same filters, two large and one small, appear original. One was replaced in 2010, and the other in 2014.

The small pool pump is leaking.

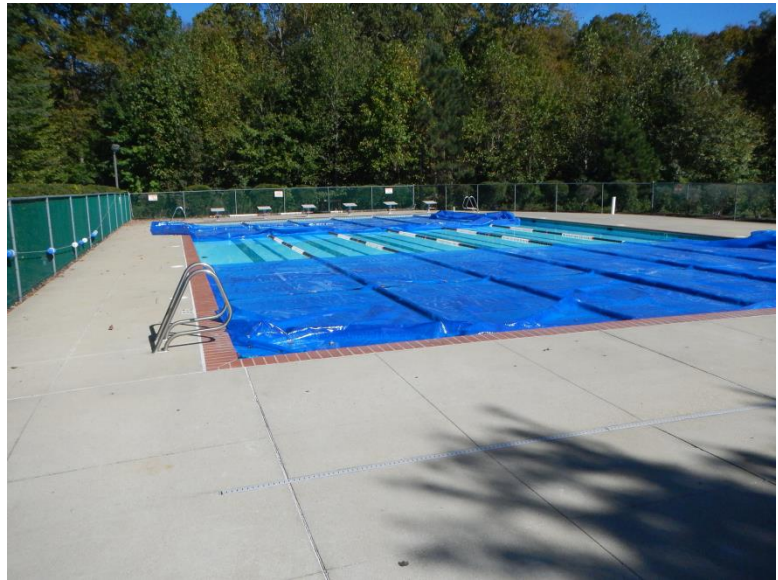
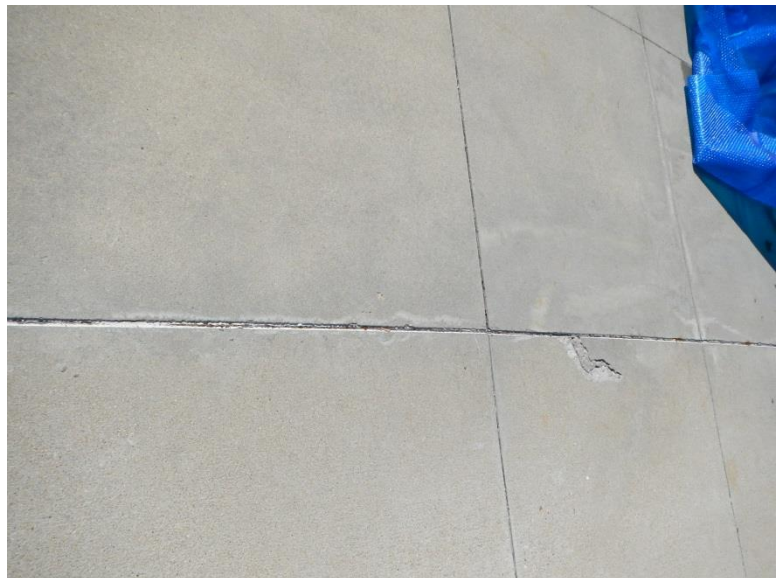
## Component 20 - Concrete Pool Deck

The pool deck is in serviceable condition at this time, however we noted some joints that need to be re-caulked. These decks are susceptible to cracking from differential settlement and are also susceptible to undermining from water leakage around the pools. It is important to maintain the sealant joint around the pools to prevent water from getting under the deck areas.

Some rust staining in the joints was noted as well as a small amount of spalling on the deck surface, indication of the age of the pool deck. We recommend that the caulk joint be cut out and the expansion joint material including the metal pour stop material be cut out and the joints restored at this time. This is a maintenance item.

The pool deck appears to largely drain at the rear of the pool area particularly at the right where a significant amount of ground erosion is occurring and undermining the pool deck and adjacent light pole. The area should be repaired with filter fabric and rip rap to prevent further erosion from damaging these components.

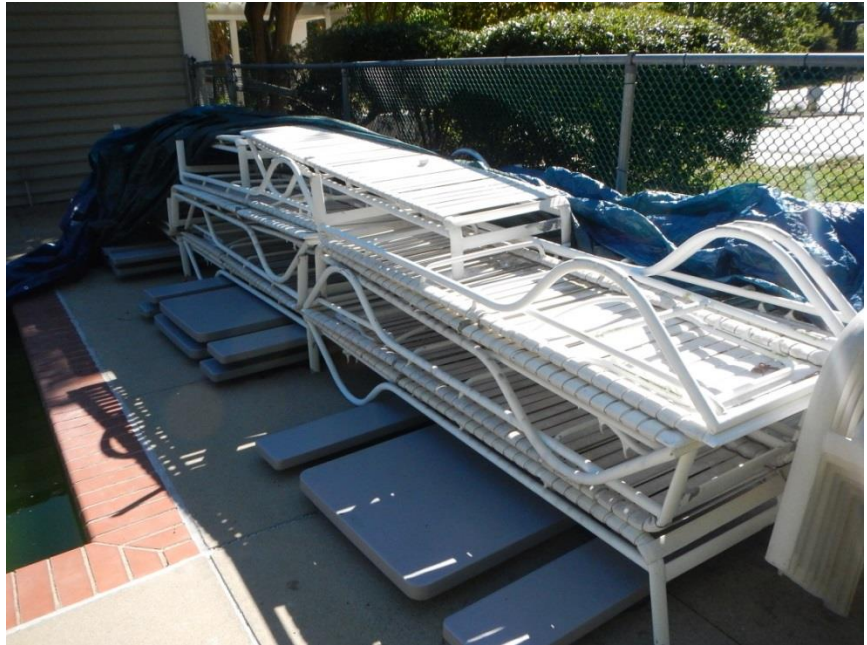
## Component 21 - Pool Furniture

The furniture appeared to be in fair condition at this time and is stored for the winter.

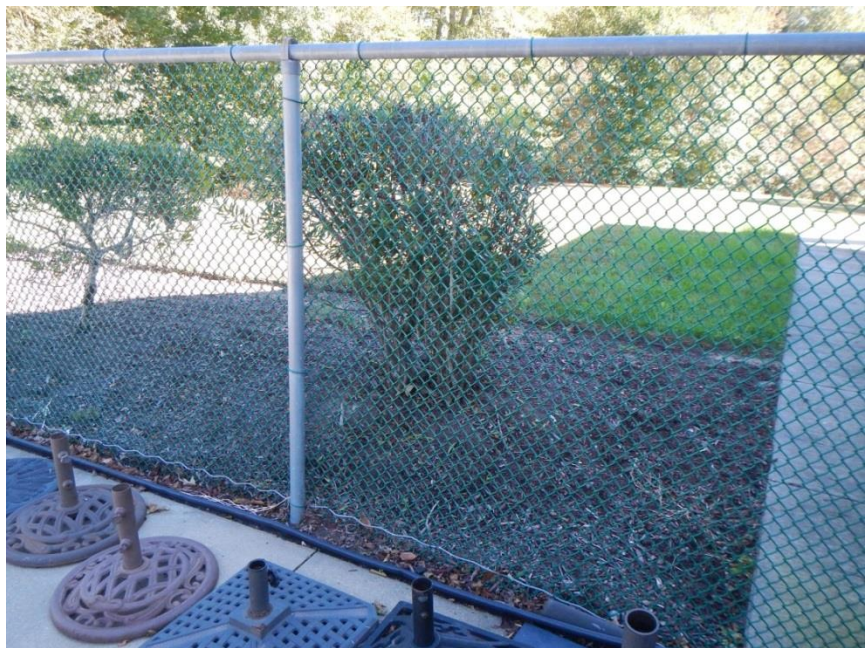
## Component 22 - Swimming Pool Fence

The pool area is surrounded by a chain link fence that is 4' high and consists of vinyl coated 9 gauge fence fabric (chain link) on galvanized 2 1/2" posts and 1-5/8" rails. Over time the vinyl coating of the fence fabric will break down and allow rusting to begin. The combination of impact damage and declining appearance quality from rust will cause

replacement of the fabric. At this time, the fence appears to be in serviceable condition.

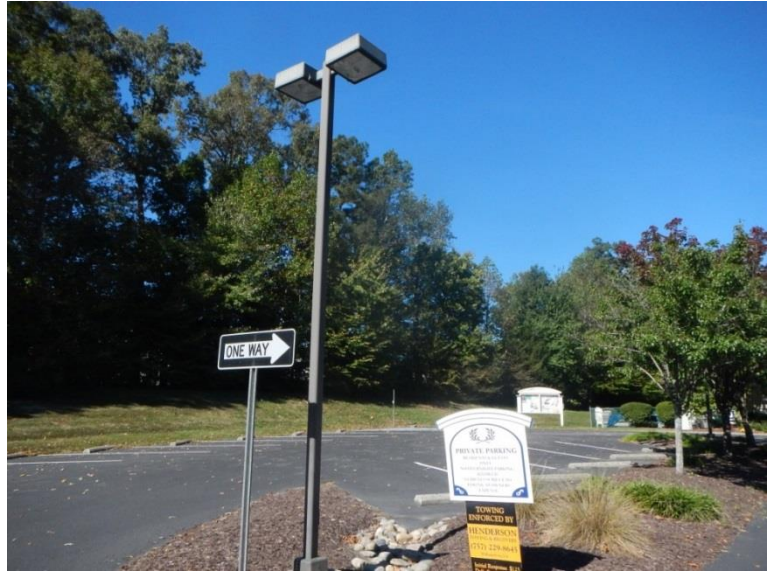
### **Component 23 - Pool Area Pole Lights**

One of the light poles and fixtures has been replaced with a new fiberglass pole and LED fixture. The remaining fixtures are in generally fair to poor condition although the poles are serviceable at this time.

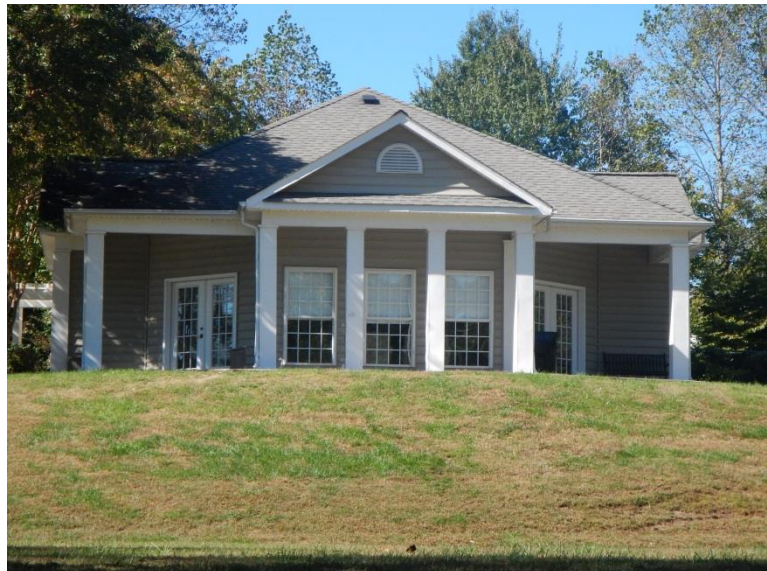
### **Component 24 - Clubhouse Roof**

The roof on the clubhouse includes an architectural laminated asphalt roof shingle and associated flashing and trim. Generally this type of roof shingle has a service life of approximately 25 to 30 years. The roof appeared to be in very serviceable condition at this time.

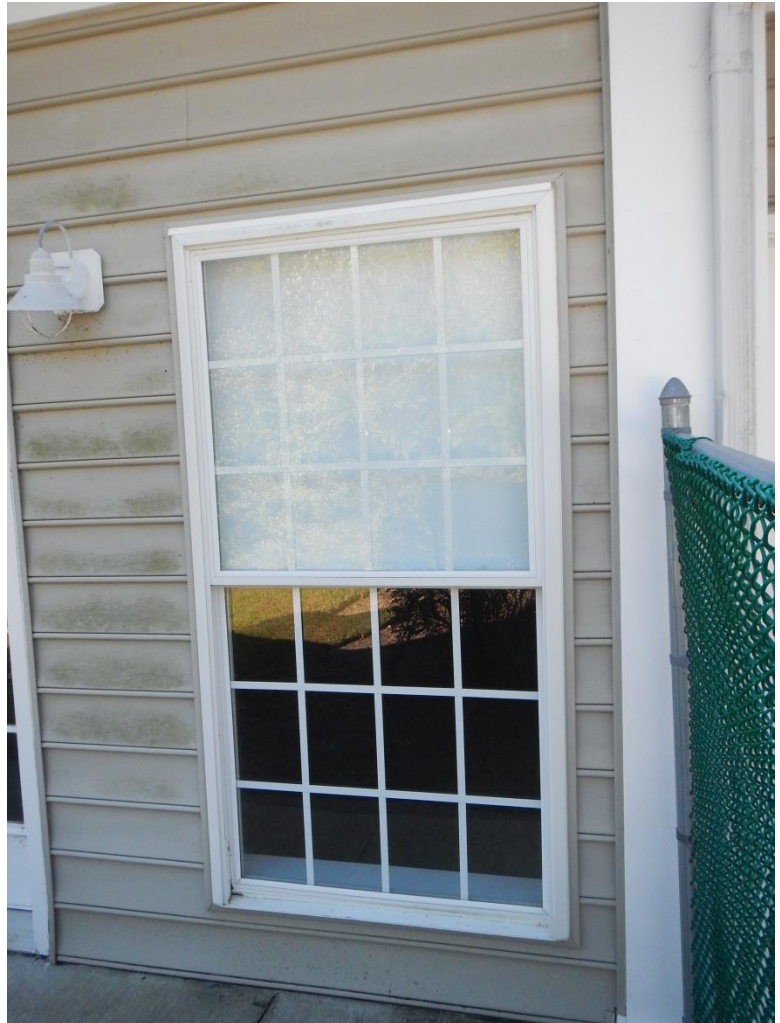
## Component 25 - Window Replacement

The windows at Westminster are PVC frames and sashes with insulating glass units. The types of failure to be expected are failures of the insulating glass system (fogging of the glass) and weathering of the plastic sashes (yellowing).

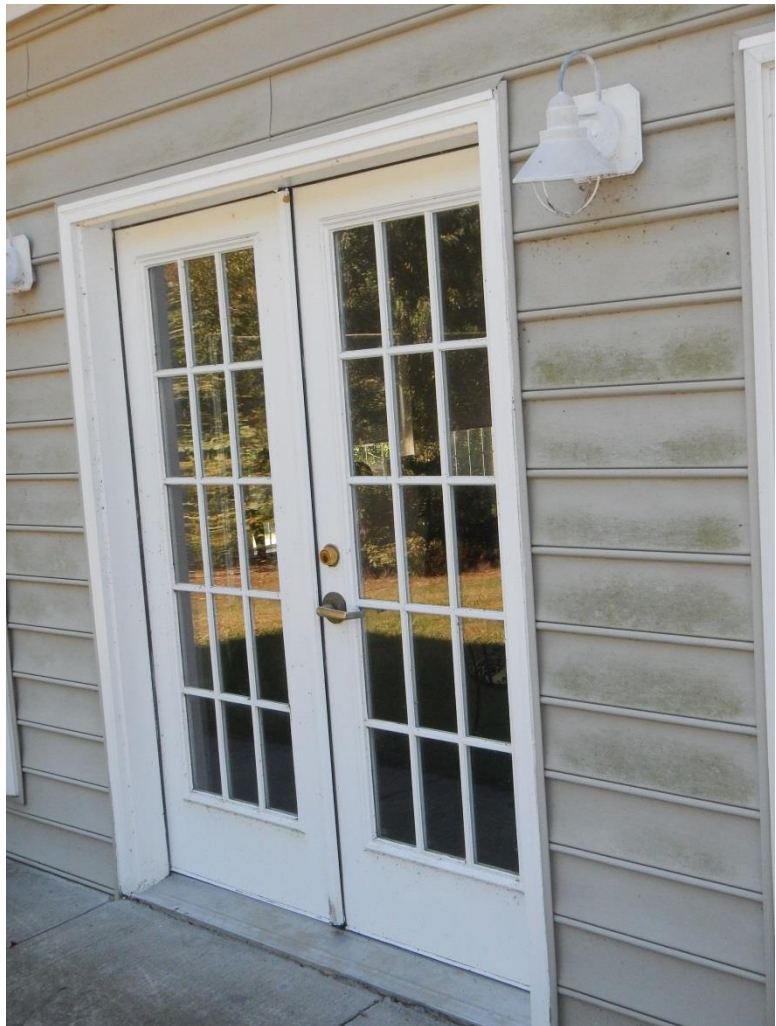
## **Component 26 - Exterior Glass Door Replacement**

There are four sets of French doors at the clubhouse. They are all metal faces, composite core doors with PVC glazing trim and insulating glass units. Like the windows, the insulation glass units are subject to failure and they tend to fail earlier indoors due to the usage (opening and closing). Other causes of failures can be rusting of components and hardware. These doors are somewhat protected, which will help preserve them.

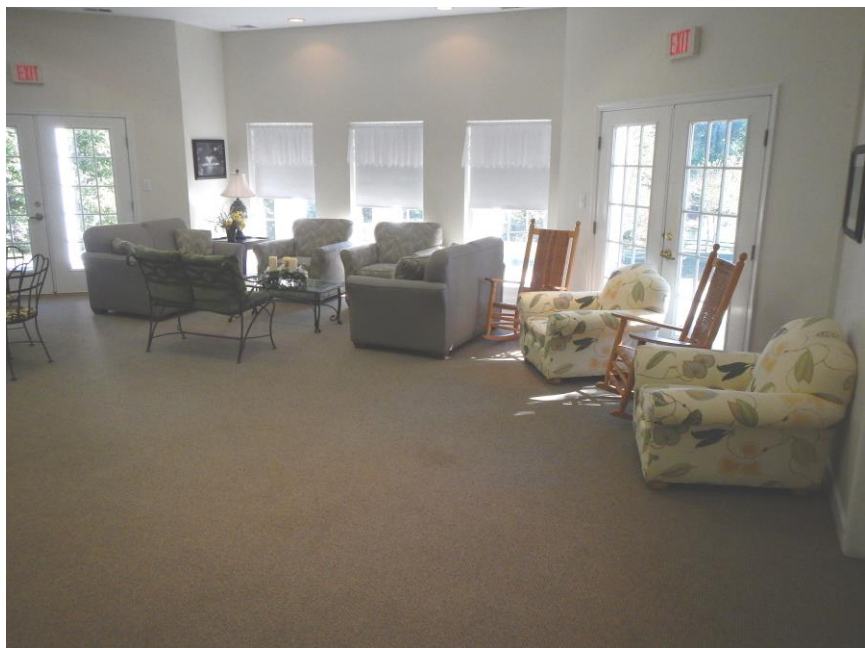
## **Component 29 - Clubhouse Carpet**

Carpet normally has about a 15 - 20 year life before it is replaced for appearance reasons. However for a clubhouse the need for more frequent replacement often occurs.

Carpeting and vinyl flooring was replaced in 2014.

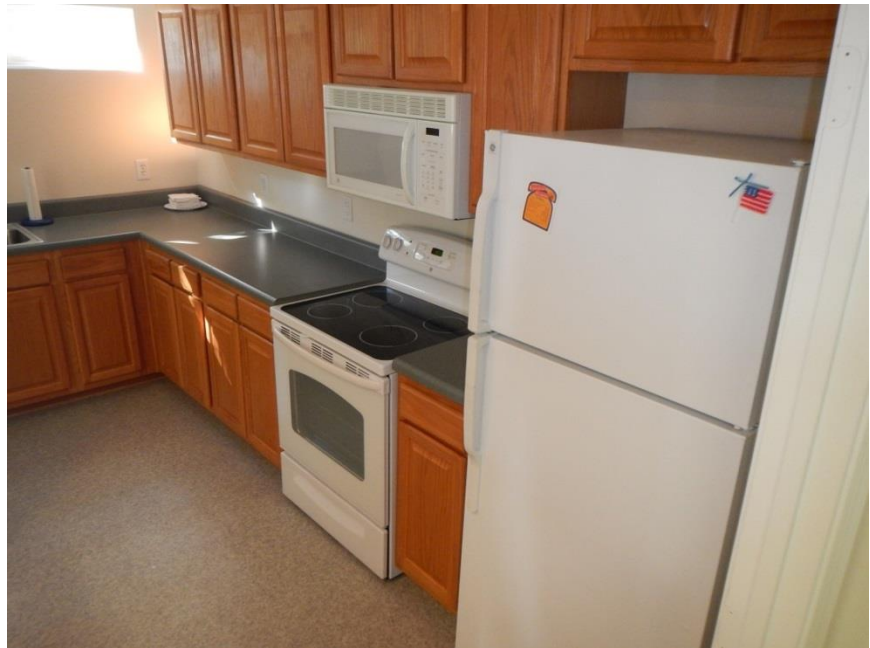
### **Component 31 - Kitchen Equipment**

Kitchen equipment was replaced 1 year ago. Kitchen equipment currently includes a GE range, GE Spacemaker microwave and a GE refrigerator/freezer. The dishwasher has been removed and will not be replaced but the association wants to replace the installed two-compartment sink. There is a second GE refrigerator in the snack room

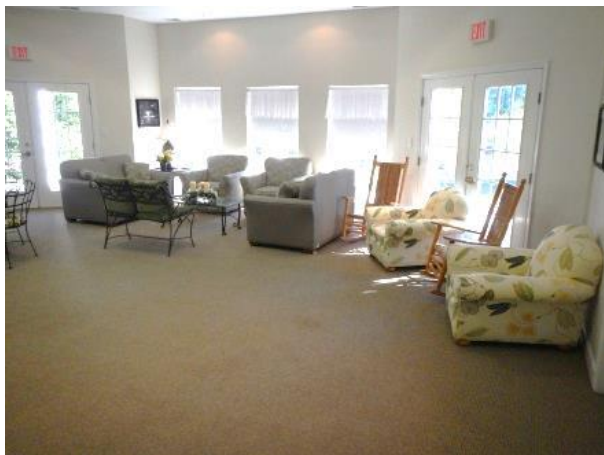
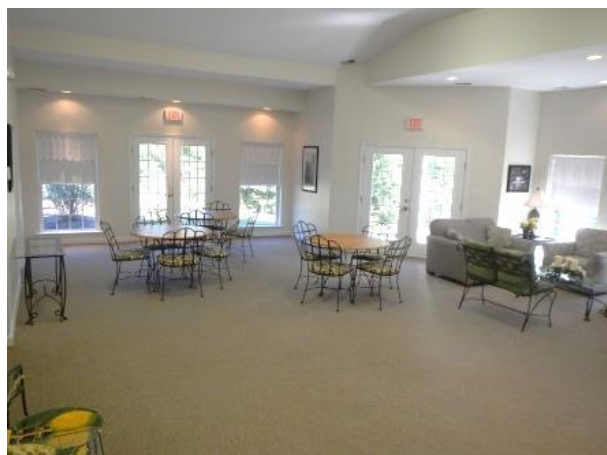
## Component 32 - Interior Furniture, Furnishings and Equipment

Life expectancies can vary widely for furnishings. However at some point general replacement will likely occur as a way of redecorating and updating the clubhouse. The earliest failures will be in the upholstered and wood furniture.

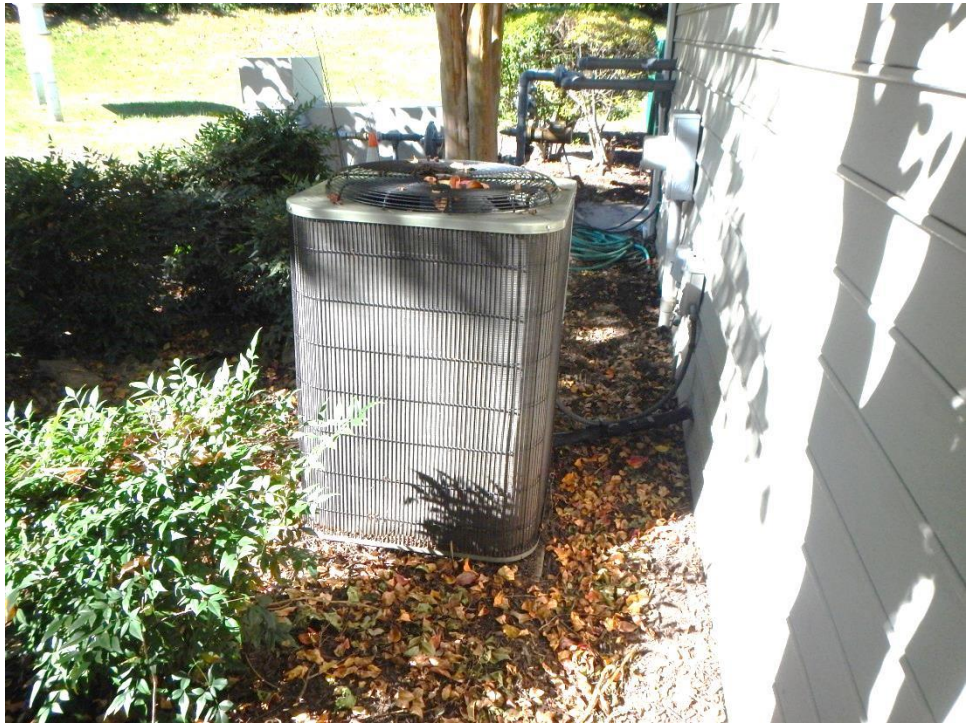
### **Component 34 - Clubhouse HVAC**

The clubhouse is heated and cooled by a residential type split HVAC system including a Carrier gas furnace located in the attic area above the kitchen and a condenser unit located outside in front of the building.

We are budgeting for a 25 year life for this system. Some compressors fail earlier though and are treated as a maintenance item.
